TEU2LA Series

EcoPower® Flush Valve,  
Urinal, Concealed Large, 0.5 Gpf

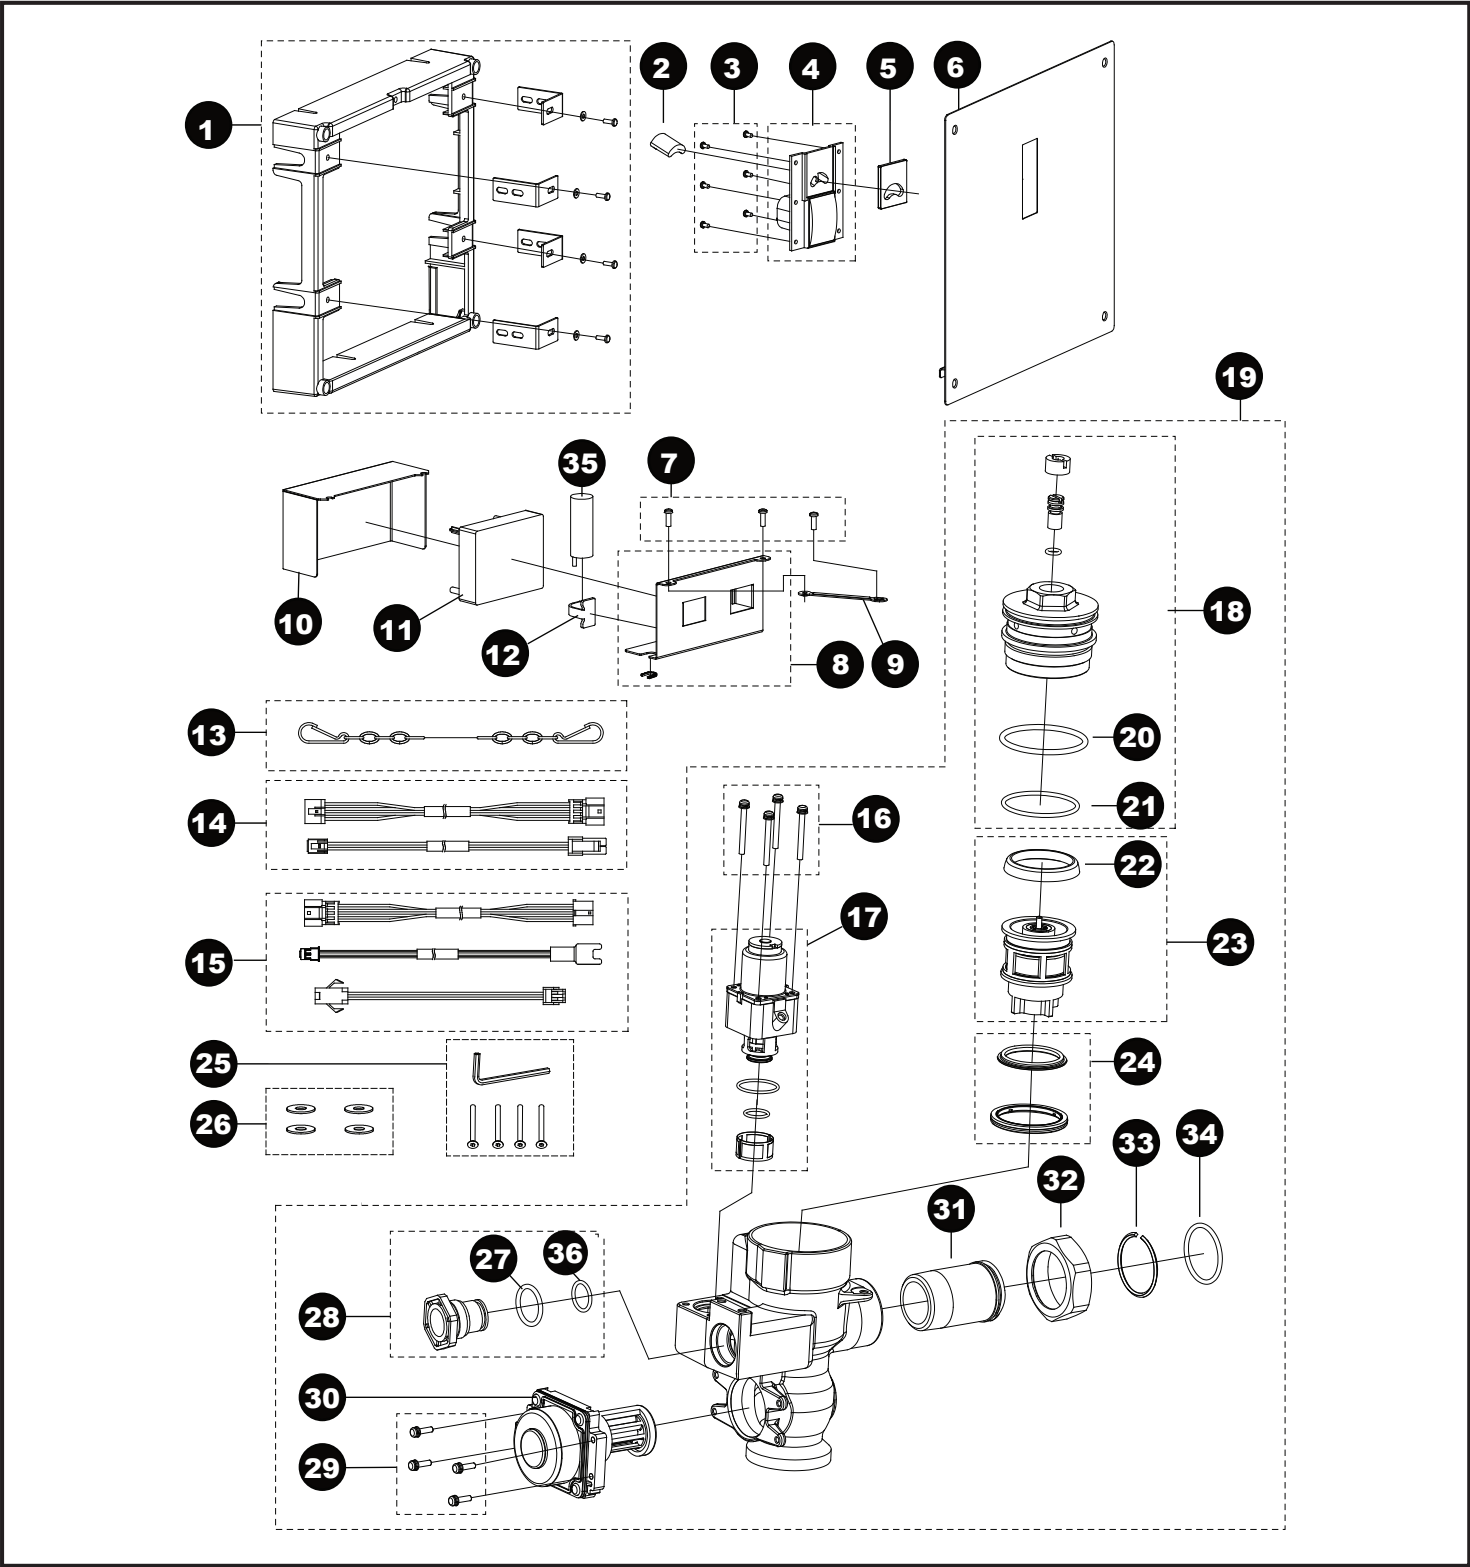
| Item | Part | Description |
| 1 | 99790121 | Frame assembly, large cover |
| 2 | 99881337 | Sensor |
| 4 | 99822376 | Bracket, sensor, w/ push button |
| 6 | 99822378 | Cover plate, large |
| 8 | 99822380 | Housing, controller, concealed |
| 13 | 99790122 | Chain, cover plate |
| 15 | 99881336 | Extension harness (3 type/bag) |
| 17 | 99822387 | Solenoid valve assembly |
| 19 | 99634292 | Valve assy, concealed, urinal |
| 23 | 99340341 | Piston assembly |
| 26 | 99822392 | Washer, plastic (4/bag) |
| 30 | 99822399 | EcoPower generator, urinal |
